B1 INSULATED CABLES
PS 1 - Learning from experiences

**Developments towards a Risk Based Maintenance program to reduce fires at
LV cable terminations and plastic enclosures**

¹Powerco Ltd., ²Unison Networks Ltd., ³EPECentre
New Zealand

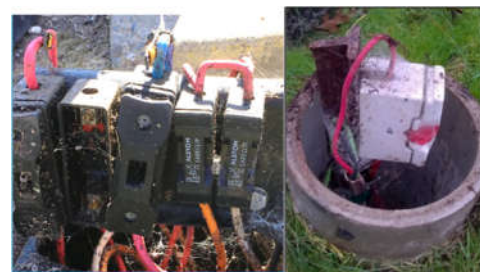
Figure 3 – examples of internal LV pillar components: mainly fuses, relays and links

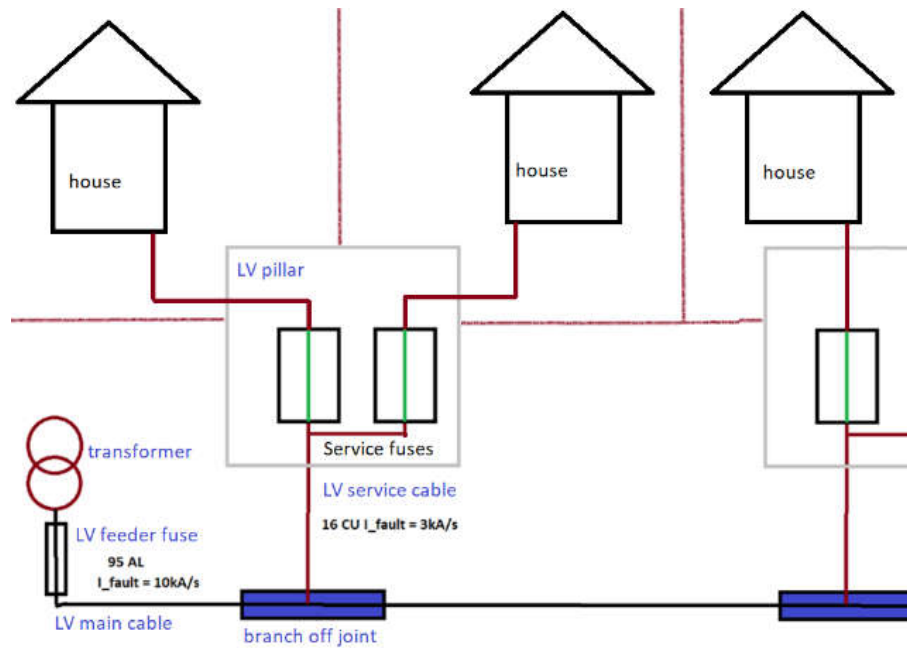
Figure 5 – typical NZ residential LV network configuration including function of plastic pillars used in the LV network: transformer, circuit fuse, main LV cable, branch off joint and short cable to pillar on the property boundary, which encloses the main service fuses for two or three dwellings

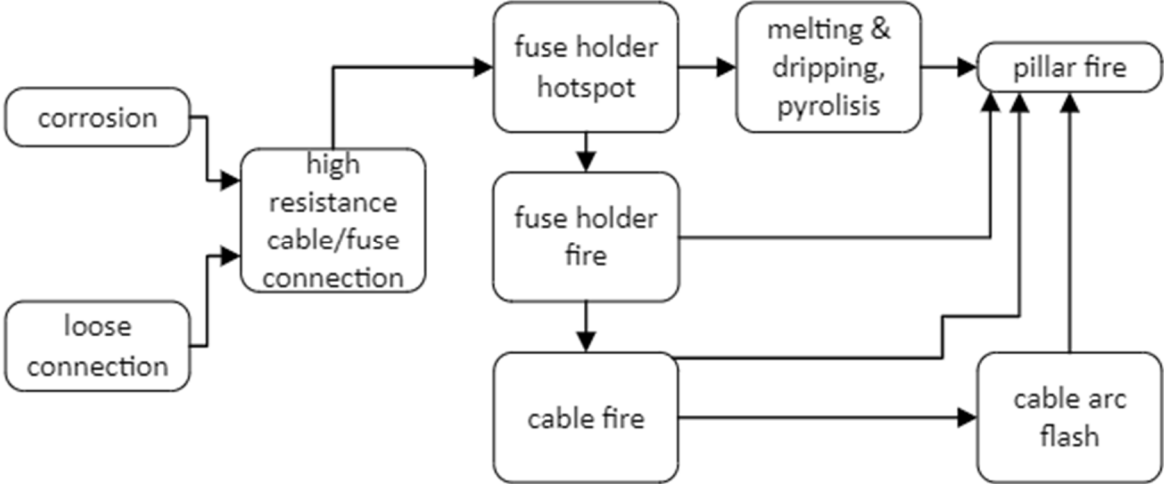
In the following sections we hope to provide sufficient evidence that one of the main failure modes is corrosion of the cable terminal of the fuse holder. This hazard is not limited to pillars; a fire at a distribution transformer has recently also been caused by a fuse. Figure 6 shows how corrosion may lead to a “pillar fire”.

Figure 6 – Simplified process diagram: from corrosion to component failure to pillar fire
