Challenges and feedback on Temporary Overvoltage (TOV) tests from CIGRE TB 852 (853)

SC B1 Insulated Cables – PS2 – Q5

HV laboratory test set-up for reproducing TOV wave shapes – challenges and feedback

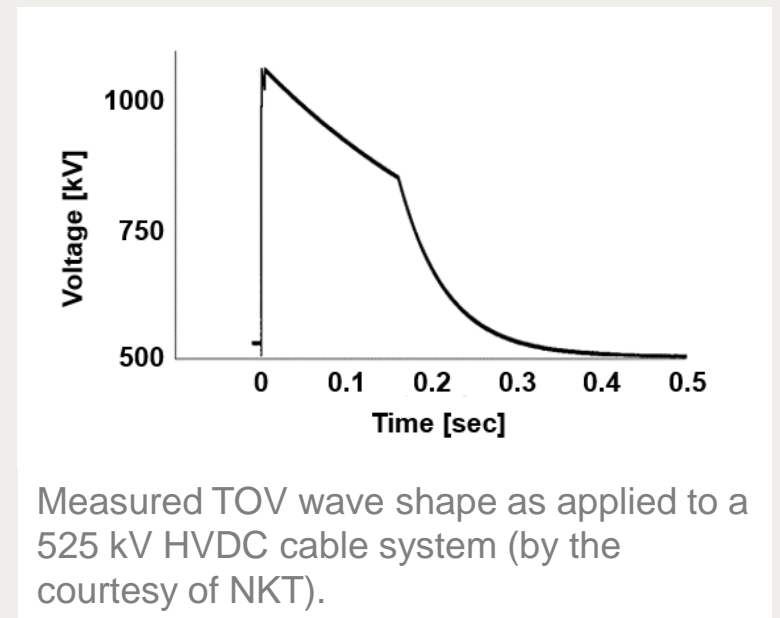
- Generation specifically of some long TOV wave shapes, have been restricted by laboratory equipment constraints.
- Reproduction of TOV wave shapes in a HV laboratory environment on a level of 525 kV is possible, but complex and comes still with many open questions and uncertainties, e.g.:
 - Lack of expertise in practical implementation.
 - Lack of experience and robustness in test execution and laboratory set-up.
 - Open questions in reproducibility, measurability, potential secondary effects.
 - Only very few labs in the world have been able to produce such wave shapes

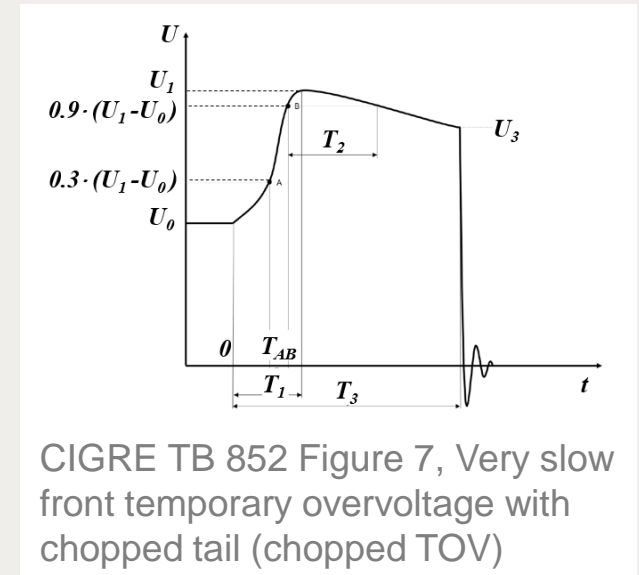
CIGRE TB 852 (853) – chopped TOV

- “Some type of converter operation” (protective)
 - Potential risk to TOV chopping on the plateau
 - Restrictions need to be discussed on TOV chopping
 - Are all relevant descriptive parameters considered in the suggested test curve?

CIGRE TB 852 Figure 7, Very slow front temporary overvoltage with chopped tail (chopped TOV)
