GROUP REF.: B2
 PREF. SUBJECT: PS2
 QUESTION No.: Q2.19

Question 2.19: What was the confidence level of the AI system inspection conductors and towers? How many images were used to train the AI for recognition?

Contribution for Q2.19

○ Development of a conductor diagnosis-imaging system using helicopter VTR and AI

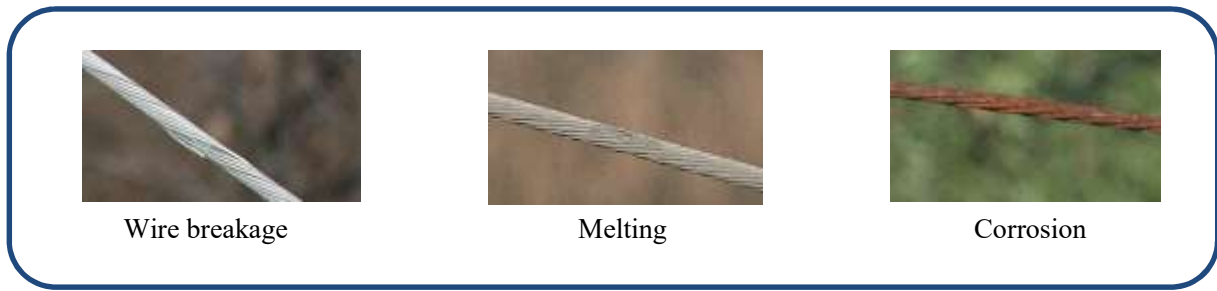
Fig. 2 Examples of failure state images used for learning

In addition, approximately 450 images recorded over five years were processed to increase the number to 7,000 before using teaching data under failure conditions. Failure conditions are defined as those in which the strength of electrical wiring machinery is considered at risk of deteriorating, e.g. due to the wiring breaking or melting.

Wire breakage

Melting

Corrosion
