Resilience Assessment 400 kV Overhead Line Stevin – Horta in Belgium

P. SMET; B. RISSE; B. PELSERS; K. VAN DAM, ELIA Asset SA
T.J. PLOEG; E. PLATENKAMP; SHAH MOHAMMADI M.R. DNV Energy Systems

Resilience Assessment 400 kV Overhead Line Stevin – Horta in Belgium continued

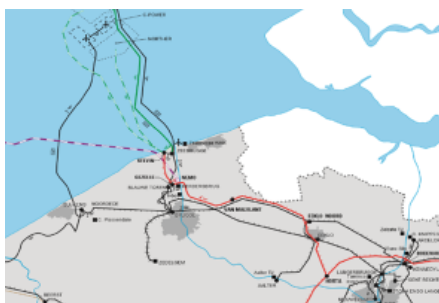
Stevin – Horta axis

- In Q1 2019, the HVDC Nemo link between UK and Belgium came into commercial operation. The Nemo link is connected to the Elia grid via the 380kV Stevin - Horta antenna.
- In addition, in case of unavailability of the 380 kV Stevin-Horta axis, the connected offshore wind farms will not be able to inject into the grid and hence have to be curtailed.

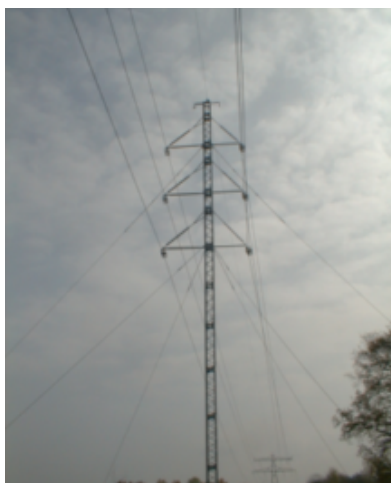
Emergency Restoration System (suspension tower)

- Contains 28 towers ((16* RA (Running Angle) and 12*AT (Angle Tower).
- Maximum possible span length about 180 m for the 4*707AMS-2Z conductor
- Angle tower and suspension tower with height extensions require 1 tower body per phase.
- The ERS is not designed and tested using the ACCC-Z Antwerp conductor or a HTLS as used in the Stevin Horta axis.

- Additional equipment is needed for the 2*ACCC-Z Antwerp / 4*707AMS-2Z conductor transition.
- The installation of structures for horizontal configuration of the phases is trained.
- Enough spare AMS conductors are in store for 5 km (one circuit 380 kV) ERS.

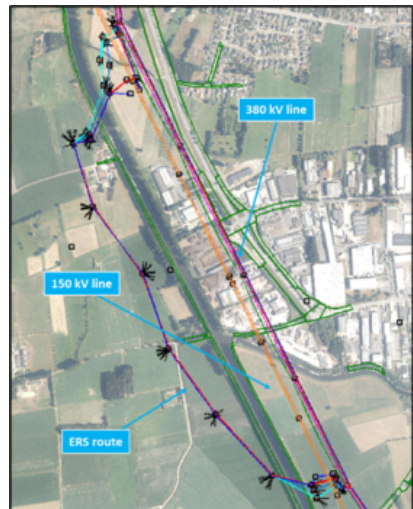
Profile drawing example critical location

- The example location is relative complex due to the surrounding infrastructure which includes a 150 kV line as well as the protected trees lining the canal.

- The ERS route crosses underneath the 150 kV line and then over the canal in successive spans which warranted the use of special structures to obtain sufficient clearance. Each structure carries one phase.

- After crossing over the canal structures there have sufficient space and are the standard ones.
- Special structures were also required to cross back over the canal. The heights of the structures were influenced by the height of the protected trees as indicated in the survey data.

- After the design stage a site- inspection was carried out at each tower location to ensure the feasibility of our ERS line design. Access roads, possible (future) tree & bushes obstructions were checked. For each ERS tower location a site plan was made
