## Study Committee B2

Overhead Lines

### Deterioration diagnosis-imaging technology and deterioration countermeasure technology for overhead transmission line

TEPCO Power Grid, Inc. (JAPAN)

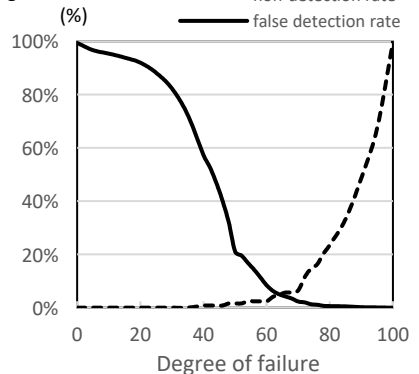
Fig.6 Judgment result of the conductor failure diagnosis

- The changes in the non-detection and false detection rates with respect to the degree of failure in 123 cases for verification are shown in Fig.6.
- The threshold value to determine the degree of failure was 62 or less when the non-detection rate was set to 5% or less
- In this case, the falsedetection rate was 6%

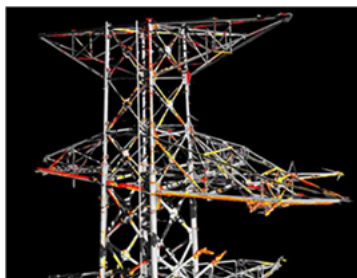
Fig.7 Example of rust extraction on the steel tower by AI

- This new diagnostic method involves filming steel towers using commercially available drones, then using AI to quantitatively evaluate the deterioration from the footage(Fig.4).
- This AI can detect deteriorated (rusty) portions of a steel tower from images, in pixel (px) units. Any rust detected in pixel units from the image is color-coded and visualized in three stages according to the degree of rusting.
- This AI includes a function allowing steel towers to be determined from imagery irrespective of the background.
