#### Paper D1-PS1-10646

## Nondestructive Terahertz and Millimeter Wave Imaging for Underfilm Corrosion

N. Fuse<sup>1</sup>, Y. Hori<sup>1</sup>, T. Takahashi<sup>2</sup> and M. Mizuno<sup>2</sup>

<sup>1</sup>Central Research Institute of Electric Power Industry, <sup>2</sup>National Institute of Information and Communications Technology

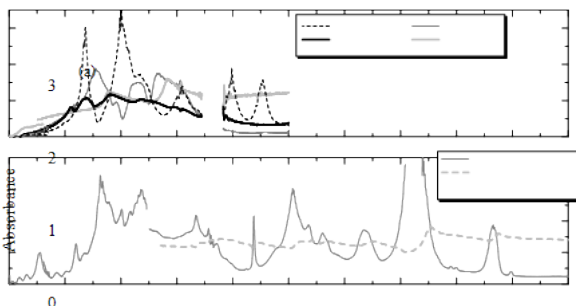
**Absorption spectra in far infrared region:** Steel rusts have characteristic spectral features that depend on their chemical structure. The absorption of an epoxy coating becomes low at frequencies lower than approximately  $300\text{ cm}^{-1}$ .

**Electromagnetic waves in far infrared region, such as terahertz waves and millimeter waves exhibit good transparency for the coatings for effective detection of hidden rust.**

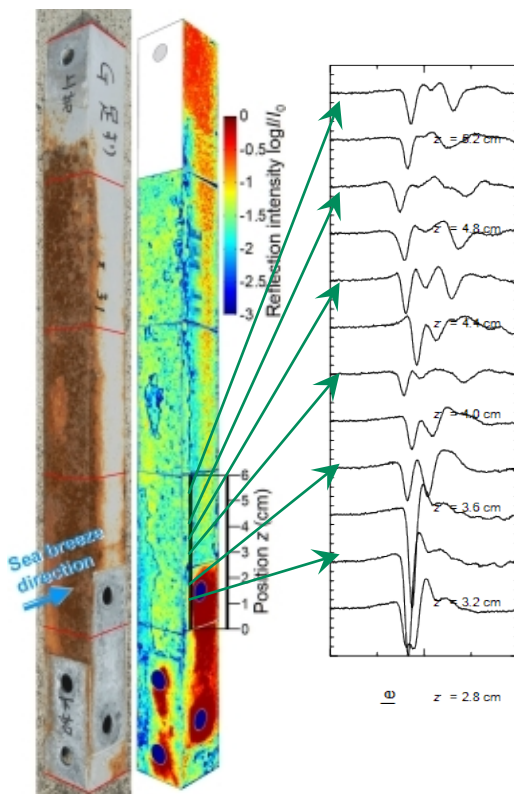
**A bar sample was removed from a power transmission tower** in a coastal area for inspection. The external appearance indicated that the corrosion was the most intense on the surface facing the sea breeze, as most of the epoxy coating was lost. The reflection intensity of the THz waves was weak on this surface. This indicated the presence of underfilm corrosion.

Reflected THz waveforms (right): **The layered structure of the metal, rust, and coating induced a series of echoes** at their interfaces when irradiated with THz pulse waves. Among the three reflection peaks observed for the areas where the coating remained intact, the second and third correspond to the reflection at the coating/rust and rust/steel layer interfaces, respectively. **The rust thickness was determined from their time delay to be 110  $\mu\text{m}$ , which agreed with direct measurement.**

**Time-of-flight measurements of THz pulse waves** are typically realized using photoconductive antennas, whereas lock-in technologies with delay lines are used for signal observation. **Two-dimensional catoptric scanner** can detect locations where **THz wave reflections are attenuated by rusting under the coating**.

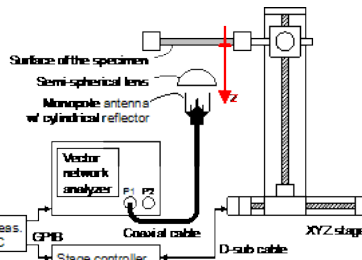
MMW antennas are already being mounted on drones for collision avoidance. **Fast imaging is, therefore, expected to be realized by arraying such small devices.** Because the diffusion of MMWs needs to be controlled for inspections, **a semispherical lens was adopted** herein to assess their effect. **Authors also developed a portable and affordable phase shift modulation module.**

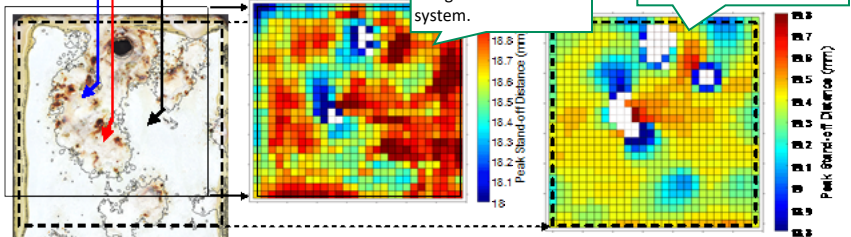
Typical  $S_{11}$  waveforms observed for the sample surfaces. The peak showed delays when the waveforms were obtained for blistered area.

MMW image obtained by traditional open-ended rectangular waveguide (Penn Eng., 1430-1BM1).

MMW image obtained using the lens-antenna system.

The blistered area detected by a 3D microscope was indicated by overwriting the contours.

- A rolled steel meeting JIS standard, galvanized and coated with siliconized epoxy resin ( $t \sim 40 \mu\text{m}$ ).
- A cyclic corrosion test in line with JASO M 609 was conducted for 1000 cycles, which corresponds to 8.3 years of exposure in Okinawa, Japan

- The  $S_{11}$  waveforms were observed along the stand-off distance  $z$ . **The waveform showed shift indicating phase delay** when the measurement was conducted on a blistered point.
- **The lens system is confirmed to suppress diffusion up to several cm of stand-off distance to provide clear image.** The image becomes imprecise when traditional waveguide was used.
- **Portable module was also developed using phase shift modulation.** Although not shown due to space limit, the interference intensity became weak when the underfilm corrosion existed, to reproduce the underfilm corrosion area.
