Identification of Partial Discharges in Cable Terminations using Methods based on Acoustic, Electromagnetic and Electrical Measurements

**Juhani TAMMI*¹, Tuukka SYRJÄNEN¹, Robert ALBRECHT², Kim BACKMAN³,
Kari LAHTI⁴, Pertti PAKONEN⁴**

**Fingrid¹, NL Acoustics², Prysmian Group Finland³, Tampere University⁴
Finland**

SUMMARY

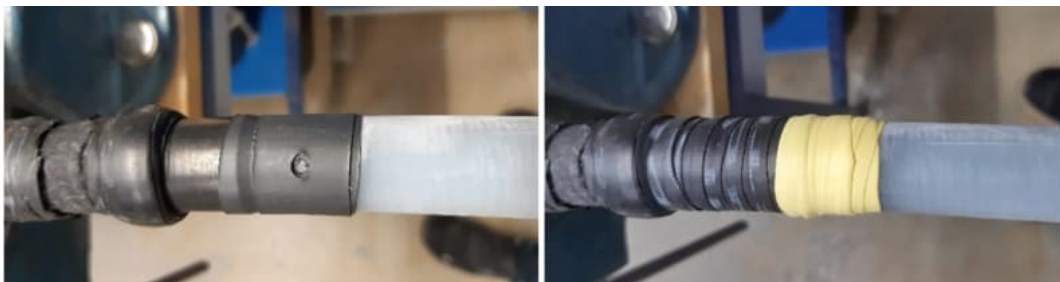
Figure 1 shows the test sample with an internal fault, where a 0.5 mm layer of insulating tube was heat shrunk around the cable to extend the semiconducting layer. This layer of tape was punctured with a hole and another same type of insulating layer was wrapped around it. Another hole was punctured through both insulating tape layers and a layer of semiconducting tape was applied over the insulating tape layers. Finally, some stress controlling tape was applied as the last layer at the end of semiconducting tape layer and everything was sealed under a heat shrink sleeve.

FIGURE 1: THE TEST SAMPLE WITH AN INTERNAL MV FAULT WITH TWO HOLES IN THE INSULATING TAPE INSERTED BENEATH THE SEMICONDUCTING TAPE LAYER.

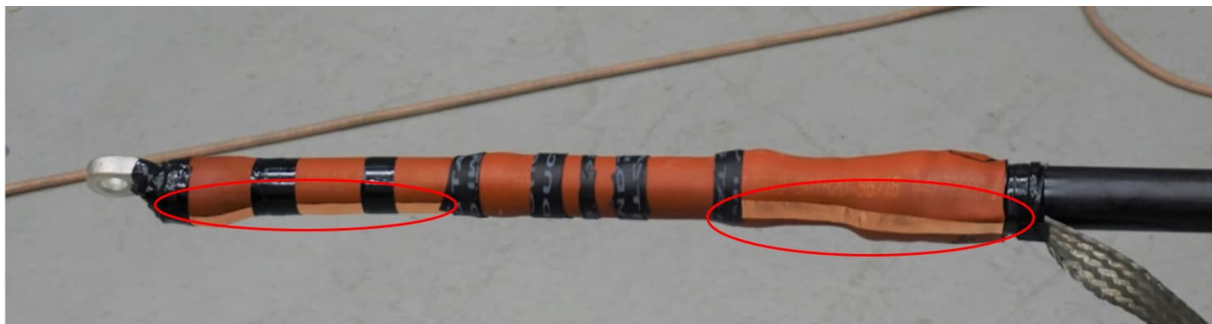
Test termination for the sample with an external MV fault was prepared according to the termination manufacturer's instructions. However, the flashover distance of the termination surface was reduced by applying copper tape and a few rounds of semiconducting tape according to Figure 3. The goal was to simulate dry band type surface discharges. The dry band fault can occur, for example, when a leakage current dries an area on a temporary conducting surface due to pollution and wet conditions. The dried area no longer works as a conductor, which creates favourable conditions for surface discharges over the dried spot.

FIGURE 3: TEST SAMPLE WITH AN EXTERNAL MV FAULT, WHERE CLEARANCE BETWEEN LIVE AND GROUNDED PART WAS REDUCED BY INSERTING TWO SECTIONS OF COPPER TAPE (HIGHLIGHTED BY RED CIRCLES) AND ROUNDS OF SEMICONDUCTING TAPE.

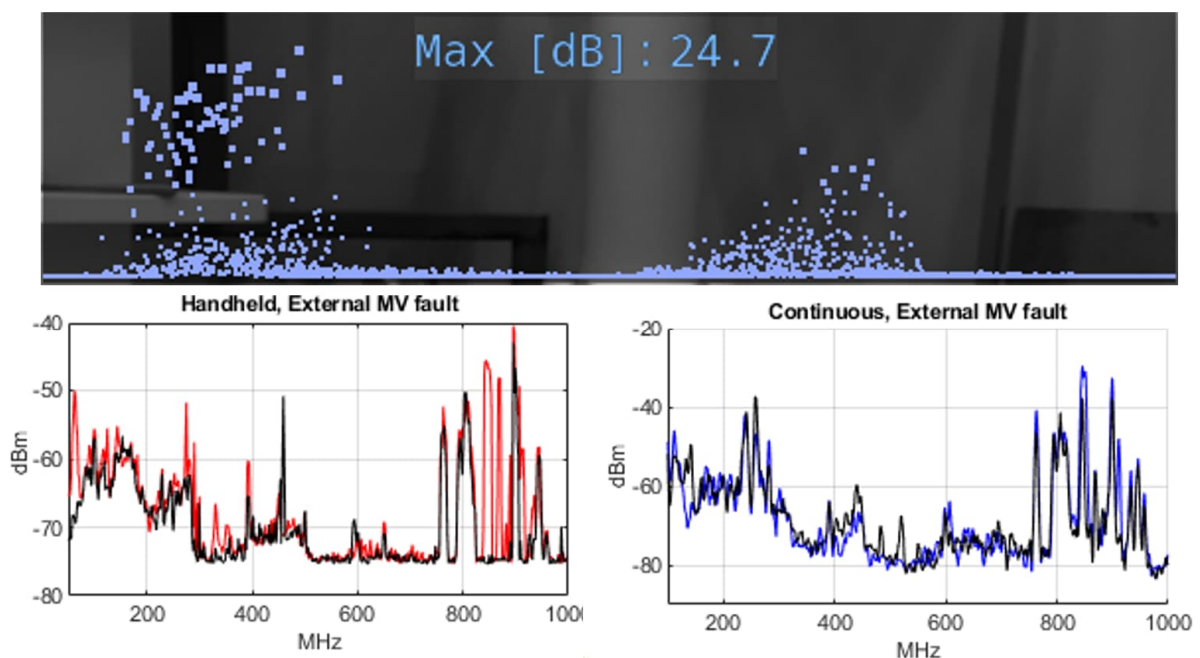
tests were performed from a distance of 3–5 m with RFI surveying tools and 1.2–5 m with an acoustic camera. The second measurement was chosen to represent the results of the RFI and the acoustic measurements of the external MV fault test sample. The results are presented in Figure 4.

The measurement was performed with RFI surveying tools from a distance of 5 meters and with an acoustic camera from a distance of 1.2 meters. The magnitude of the partial discharges in this measurement was approximately 5.5 nC and the used voltage was 11 kV. The handheld RFI surveying tool recognized the surface discharges right at the beginning of its frequency spectrum at 50–150 MHz. The continuously measuring RFI device did not perform in the recognition that well, which is most likely due to the frequency range of the device, which starts from 100 MHz. The handheld device measured most of the deviations under the frequency of 100 MHz. Nevertheless, small deviations can be noticed at frequency range of 100–115 MHz in the results of the continuously measuring RFI surveying tool. The acoustic camera performed well in the measurements, and it recognized partial discharges clearly from the distance of 5 m, where the highest measured signal level was 13.6 dB. The highest measured signal level was 24.7 dB from a distance of 1.2 meters, which is shown in Figure 4.

FIGURE 4: THE MEASUREMENT RESULTS OF THE ACOUSTIC CAMERA (ON TOP), THE HANDHELD RFI TOOL (BOTTOM LEFT) AND THE CONTINUOUS RFI TOOL (BOTTOM RIGHT) FROM THE TEST SAMPLE WITH AN EXTERNAL MV FAULT.

Other test samples causing external discharges were also recognized with the RFI devices with the exception of one test sample, which the continuously measuring RFI surveying tool did not recognize. The acoustic camera recognized all the external discharges exceptionally well.

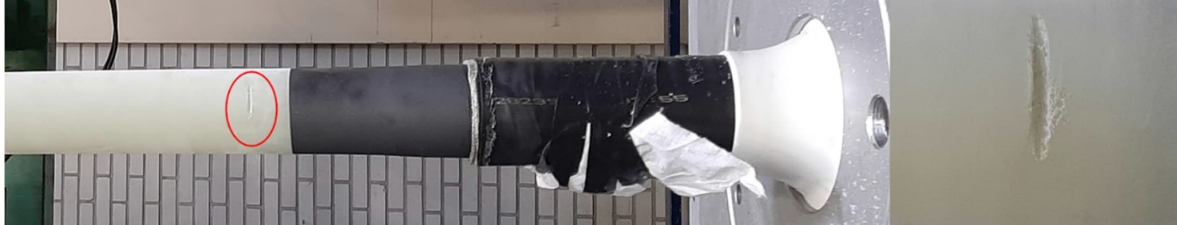
In the test sample with an internal fault, the cable insulation was damaged by using a saw according to Figure 5. The introduced cut remained under the stress cone when termination was assembled. In service, this type of fault would present a coarse and very severe installation error.

FIGURE 5: TEST SAMPLE WITH AN INTERNAL HV FAULT, WHERE THE INSULATION WAS CUT IN A PART OF THE CABLE BENEATH THE STRESS CONE.

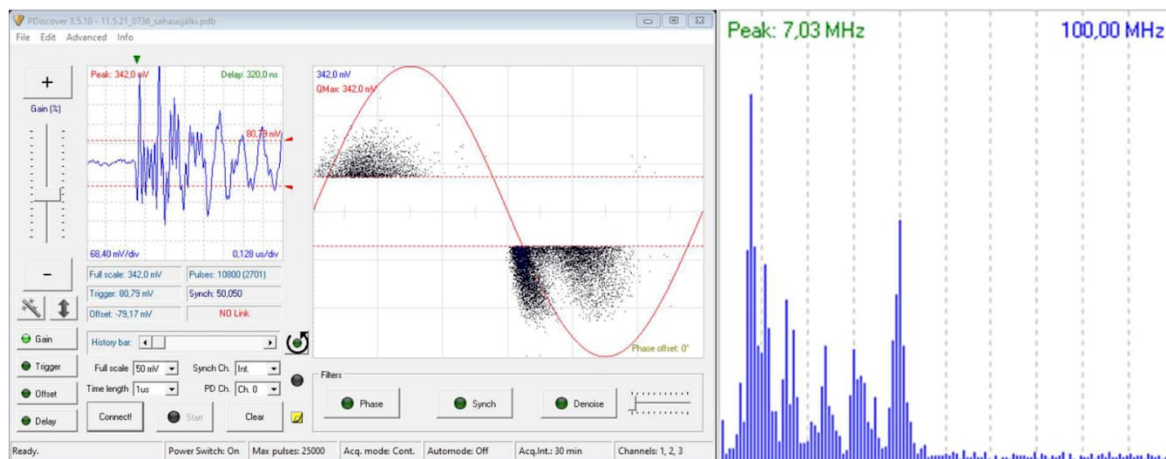
In addition, an example of measurement results produced by the portable partial discharge analyser are shown in Figure 7. The PRPD indicates clear internal discharges as expected.

FIGURE 7: THE MEASUREMENT RESULTS OF THE PORTABLE PARTIAL DISCHARGE ANALYSER FROM TEST SAMPLE WITH AN INTERNAL HV FAULT. THE ANALYSER PRODUCES THE PARTIAL DISCHARGE WAVEFORM (LEFT), THE PRPD PATTERN (MIDDLE) AND THE FREQUENCY SPECTRUM (RIGHT).
