Resilience Assessment 400 kV Overhead Lines Stevin – Horta in Belgium

P. SMET; B. RISSE ;B.PELSERS; K. VAN DAM.

ELIA Asset SA

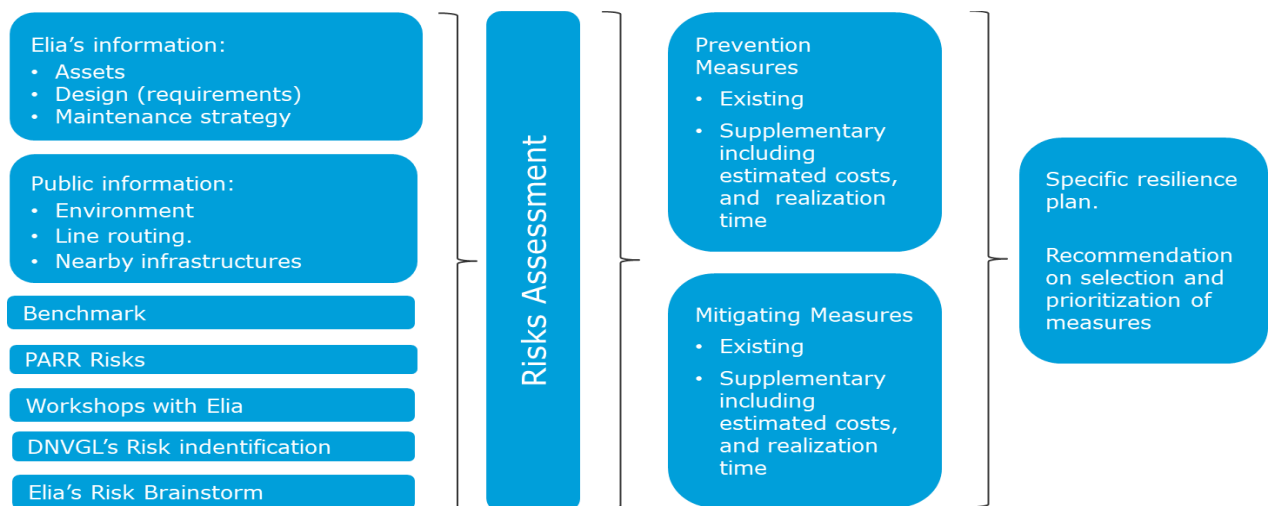
Figure 2 Risk assessment framework

Figure 2 provides an overview of the framework of the executed risk assessment. The assessment also includes some feasibility studies regarding the installation of the ERS at specific sites.

Inputs for this risk assessment were the project related documents about installation, maintenance, and operations, and the design information of the overhead lines assets. Also information about the available Emergency Restoration System was used as input.

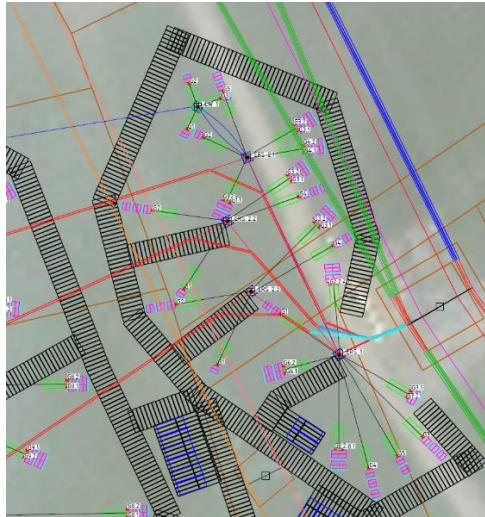
Figure 5 Site plan example

After the design stage a site- inspection was carried out at each location to ensure the feasibility of our ERS line design. Access roads, possible (future) tree & bushes obstructions were looked upon and if needed the design was slightly altered. For each ERS tower location a site plan was made as it shows in the figure 5.

An extensive soil survey was carried out in which the soil resistivity was established on each location of an ERS tower. In that way the best possible approach for the anchoring of the guywires was established up front. For each location also so called “capacity planning” was developed in which a detailed building, maintenance and decommission planning format has been provided in order to minimize response time in case of an emergency situation on one of the locations concerned.
