**B2 Overhead Lines****PS2: Latest Techniques in Asset Management,  
Capacity Enhancement, Refurbishment****Deterioration diagnosis-imaging technology and deterioration countermeasure  
technology for overhead transmission line**

In this report, countermeasures against these challenges (image deterioration diagnosis technology and deterioration countermeasure technology), are specifically introduced as follows:

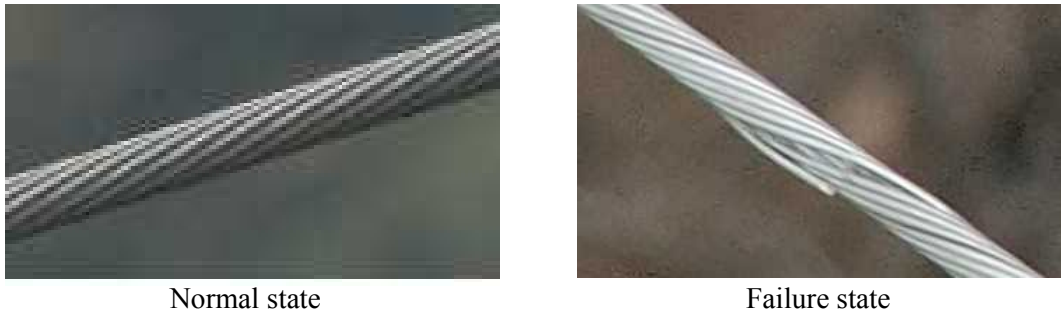
Figure 1. Normal and failure states of conductor

Since our transmission lines traverse varied terrain, from mountainous areas to urban sprawls, our inspection methods, whether ground, airborne and helicopter VTR inspections, must take prevailing conditions into account. Of these inspection methods, helicopter VTR inspection involves a worker checking and inspecting the VTR via slow-motion playback at 1/10 normal speed, which normally takes around 1,330 hours a year. The following examples show the normal and failure state of the conductor filmed via VTR (Figure 1). When compiling such VTR footage, the vast majority of transmission lines are in a normal state and very few are prone to failure. Since workers have been required to assess whether a line is normal or subject to failure while visually checking similar VTR images for extended periods, the burden on them was considerable and inspection methods like this have depended on their personal skill. This was the challenge of this method.

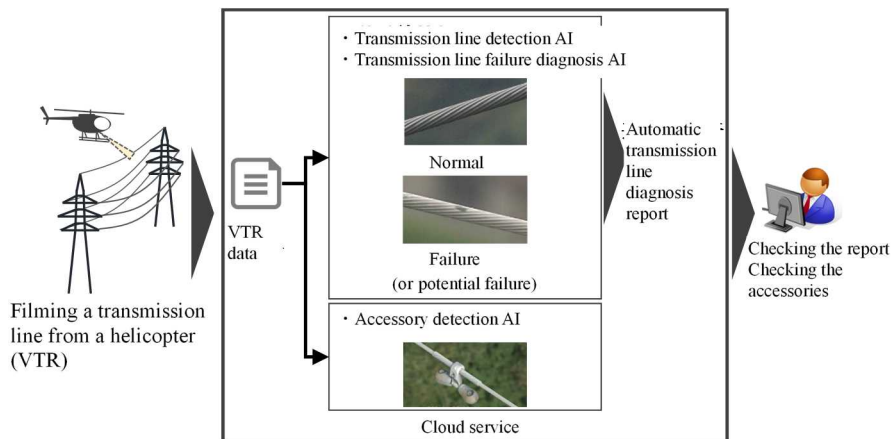
Figure 2. Overview of conductor diagnosis-imaging system

This system uses a cloud service to manage the data centrally and streamline the process of data sharing (Figure 2). Helicopter VTR footage is uploaded to this system, diagnosed by AI and a report is then automatically issued on parts deemed to have failed (Figure 3). Consequently, VTR checking and inspection time can be shortened.

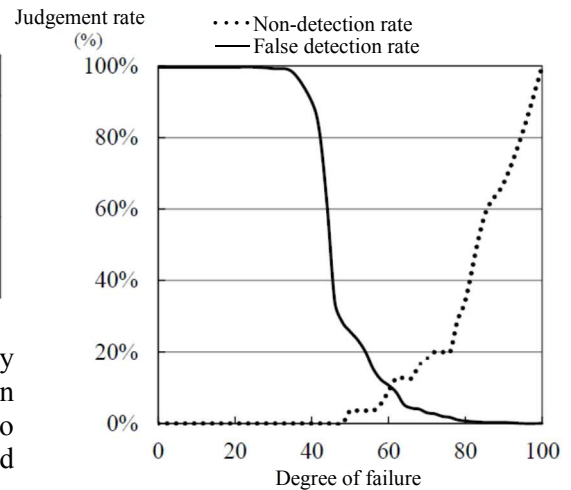
Figure 5. Judgment result of the conductor failure diagnosis

The non-detection rate means the ratio of conductor failure cases that were undetectable by conductor failure diagnosis AI and was applied to the judgment rate of failure images. The false detection rate means the ratio of images that did not correspond to conductor failure but were mistakenly assessed as such by the conductor failure diagnosis AI and was applied to the judgment rate of the normal images. The changes in the non-detection and false detection rates with respect to the degree of failure in 123 cases for verification are shown in the following (Figure 5).

Both the non-detection and false detection rates should be as low as possible, although their relationship is an inversely proportional trade-off. It was confirmed that the threshold value to determine the degree of failure was 62 or less when the non-detection rate was set to 5% or less to reduce the non-detection rate. In this case, the false detection rate was 6% and it was hypothesized that applying this system, even given the need to tolerate some non-detection and false detection, would save significant inspection time compared to conventional inspection methods using VTR slow-motion playback. In future, a further reduction in the non-detection rate can be expected by applying additional learning to the conductor failure diagnosis AI.

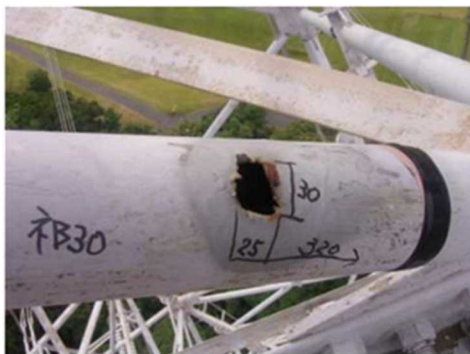
Figure 9. Pitting of a steel pipe member

Hot-dip galvanized steel is generally used for steel towers to ensure long-term rust prevention performance. Steel pipes are often used for large steel towers given their mechanical strength but pitting in members due to the progressive corrosion inside steel pipes, presumably due to defects during manufacturing and aging, have been confirmed (Figure 9). Steel pipe members affected by pitting should preferably be replaced with new equipment, given the potential for a significant decline in strength, but the need to temporarily release stress and high cost of replacement are problematic. Accordingly, technology allowing members subject to pitting to be repaired on site economically and promptly was sought.
