10135 SCB2 - Overhead Lines PS3 - Enviromental and Safety Aspects from OHL

# DEVELOPMENT OF METHODOLOGY FOR INSULATOR REPLACEMENT IN ±800 KVDC STRINGS USING LIVE LINE PROCEDURES

UHVDC - Transmission line - Live line maintenance - Tool - Glass insulator - Test - Laboratory

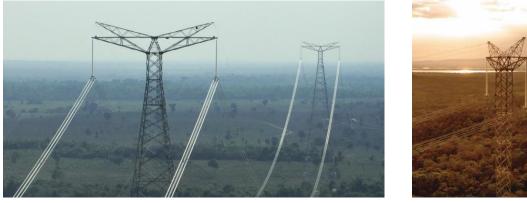
**Figure 1** – (a) BMTE's ±800 kVDC TL [1], (b) XRTE's ±800 kVDC TL [2], (c) schematic routes of the two bipoles (in blue, adopted from [3])

Figure 1 shows towers of both bipoles and the schematic routes of the two transmission lines.

As one can see, both bipoles have a single suspension I-type arrangement of insulator strings. They are composed by two types of large-tonnage cap and pin glass insulators, as established in the basic project [4]. Figure 2 and Table I present their characteristics. Suspension insulator strings of 39 units (320 kN) and 40 units (420 kN) are used. The tension insulator strings are composed of four parallel strings with 41 units (420 kN) in each.
