Paris Session 2022

Risks from HVDC Bushings SC A2 PS1 Q4 Which requirements are necessary for HVDC converter transformers to do a risk and condition assessment to ensure that they will perform satisfactorily? Simon RYDER (GB)

Risks from HVDC Bushings

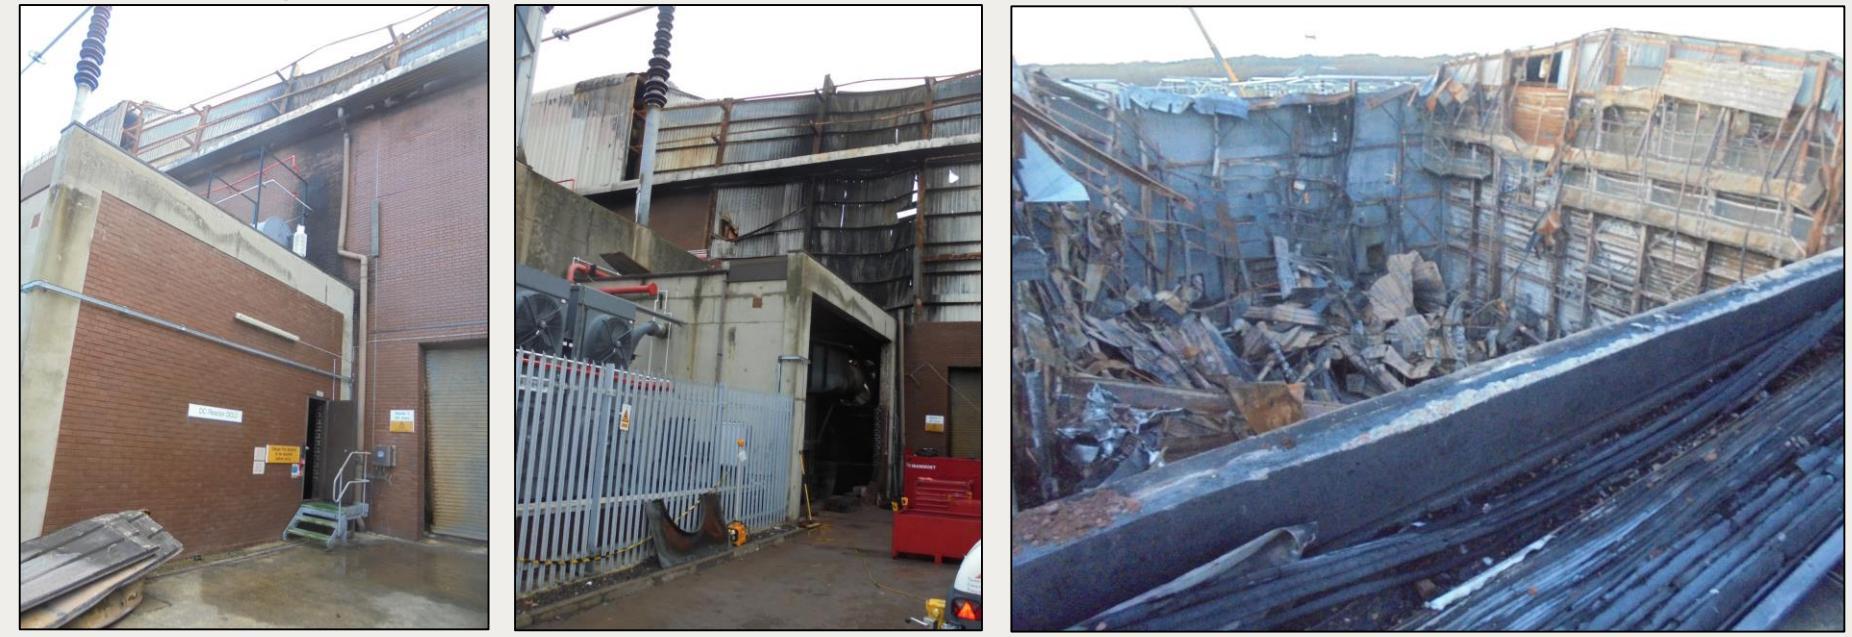
Many HVDC transformers have the bushings mounted in the horizontal position, on turrets extending through the wall of the main building. The same also applies to HVDC smoothing reactors used in some older interconnectors. This simplifies the site design and eliminates the need for a through-wall bushing. <u>But</u>, what if the bushing fails...

An inherent risk with this design is that a bushing failure will lead to uncontrolled loss of oil from the transformer into the building and likely also a major fire, which will be difficult to control or extinguish.

- Eliminating the risk from new HVDC interconnectors by using outdoor transformers with bushings in the vertical position, and wall bushings to connect into the building
- Bushing monitoring on existing HVDC interconnectors where this risk is present. Might not be applicable in all cases, esp. smoothing reactor bushings.
- Dissolved gas monitoring on existing HVDC interconnectors, as progressive bushing failure can likely be detected in this way too.
